# **STATIONARY LOW-POWER PLANT NUMBER 1, SL-1 ACCIDENT**

©M. Ragheb  
11/10/2020

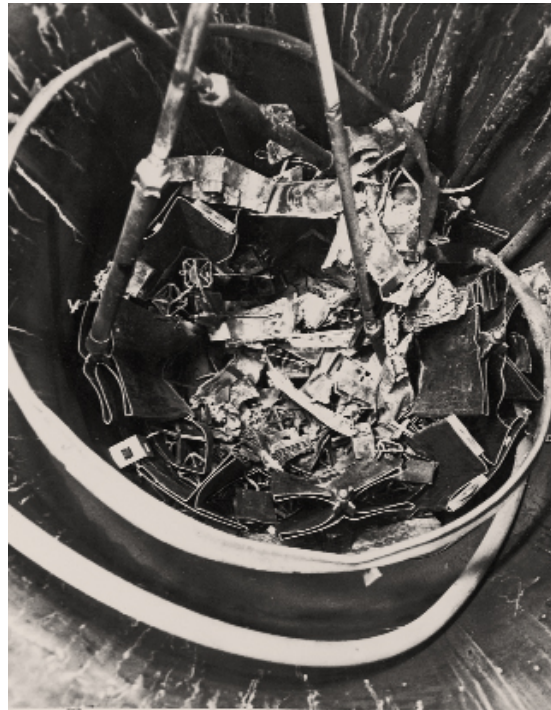
Iron pellets packed near the reactor as thermal insulation and radiation shielding scattered over the floor. The water hammer expelled the control-rod shield plugs, water, fuel fragments, fission products, and other metal from the top of the reactor, leaving open holes.

Figure 5. Top view of the damaged SL-1 core.

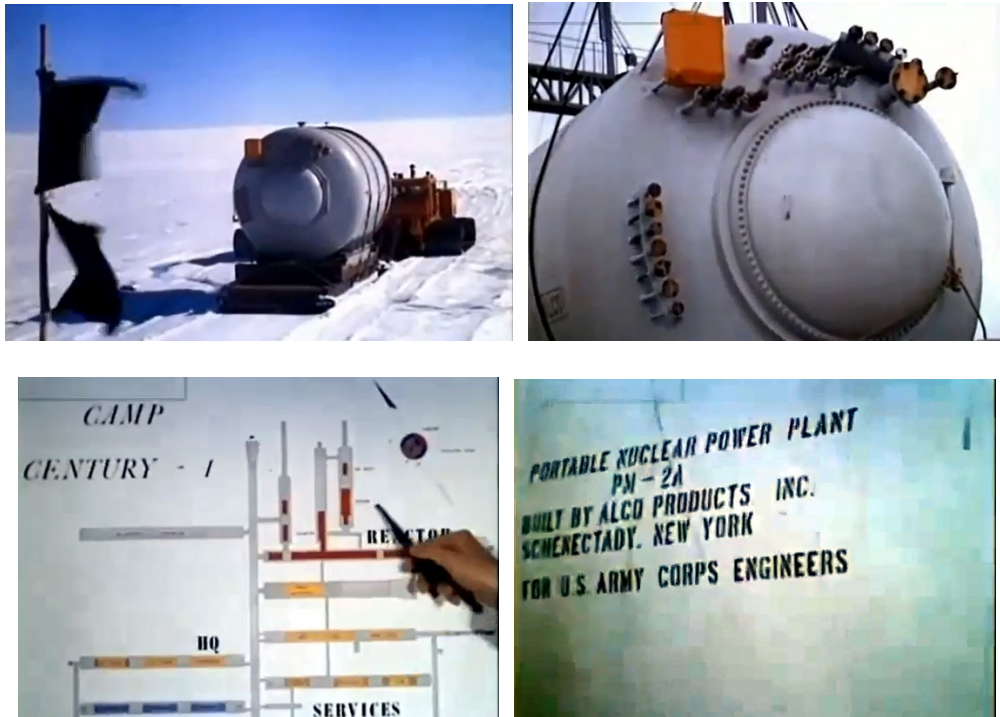
Figure 6. USA Army's Camp Century-1, Greenland, Denmark Portable Nuclear Power plant PM-2A, pressure vessel. Source: USA Army.
